SVE BULLETIN

QVM Bulletin: Q-178

Date: 21 April, 2009

F53/ F59(2011) OBDII Diagnostic Connector Location

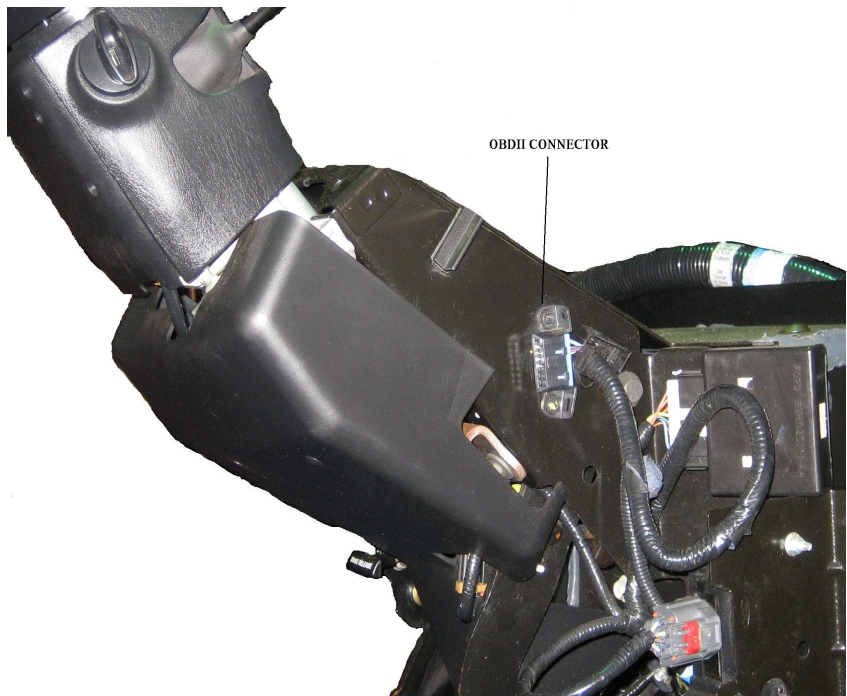
The OBDII diagnostic service port connector is attached to the right hand side of the steering column support during chassis assembly. This is intended to be a "temporary shipping location". It is the responsibility of the body builder to relocate the OBDII diagnostic connector to the bottom of the dash panel (not supplied by Ford).

Per SAE J1962 and ISO 15031-3, the OBDII diagnostic connector preferred location is under the dash panel, under the steering, +/- 150mm (i.e., +/- 6 inches on either side of the steering column).
