QVM Bulletin: Q-231

### **F-150 Aftermarket Direct to Battery Connections**

**Models Affected:** All 2015MY and later F-150 vehicles

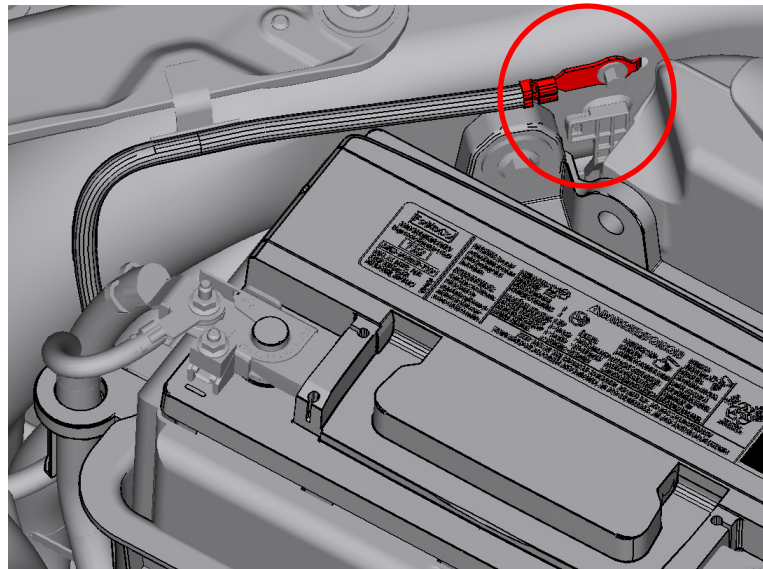
**Description:** The 2015MY F-150 battery charge state is determined with a Hall Effect sensor on the negative battery lead. All negative current must pass through this sensor. Failure to do so will result in malfunction of the vehicle charging system and shortened battery life. **Do not make direct to battery connections at the negative battery post.**

**Procedure:** To ensure proper charging system function, the battery return should be made at the grounding point shown and circled in red in the picture below:

**Addition grounding point specifications:**

Eyelet ID: 7mm  
Bolt: M6  
Torque: 9 +/- 1.4 Nm
